TETRA TECH

October 3, 2018

**Subject: Limited Asbestos Survey – USPS Seattle - Columbia Carrier Annex
3613 South Juneau Street, Suite 101, Seattle, Washington 98118
(WO 119.00, IQC 072382-15-J-0029)**

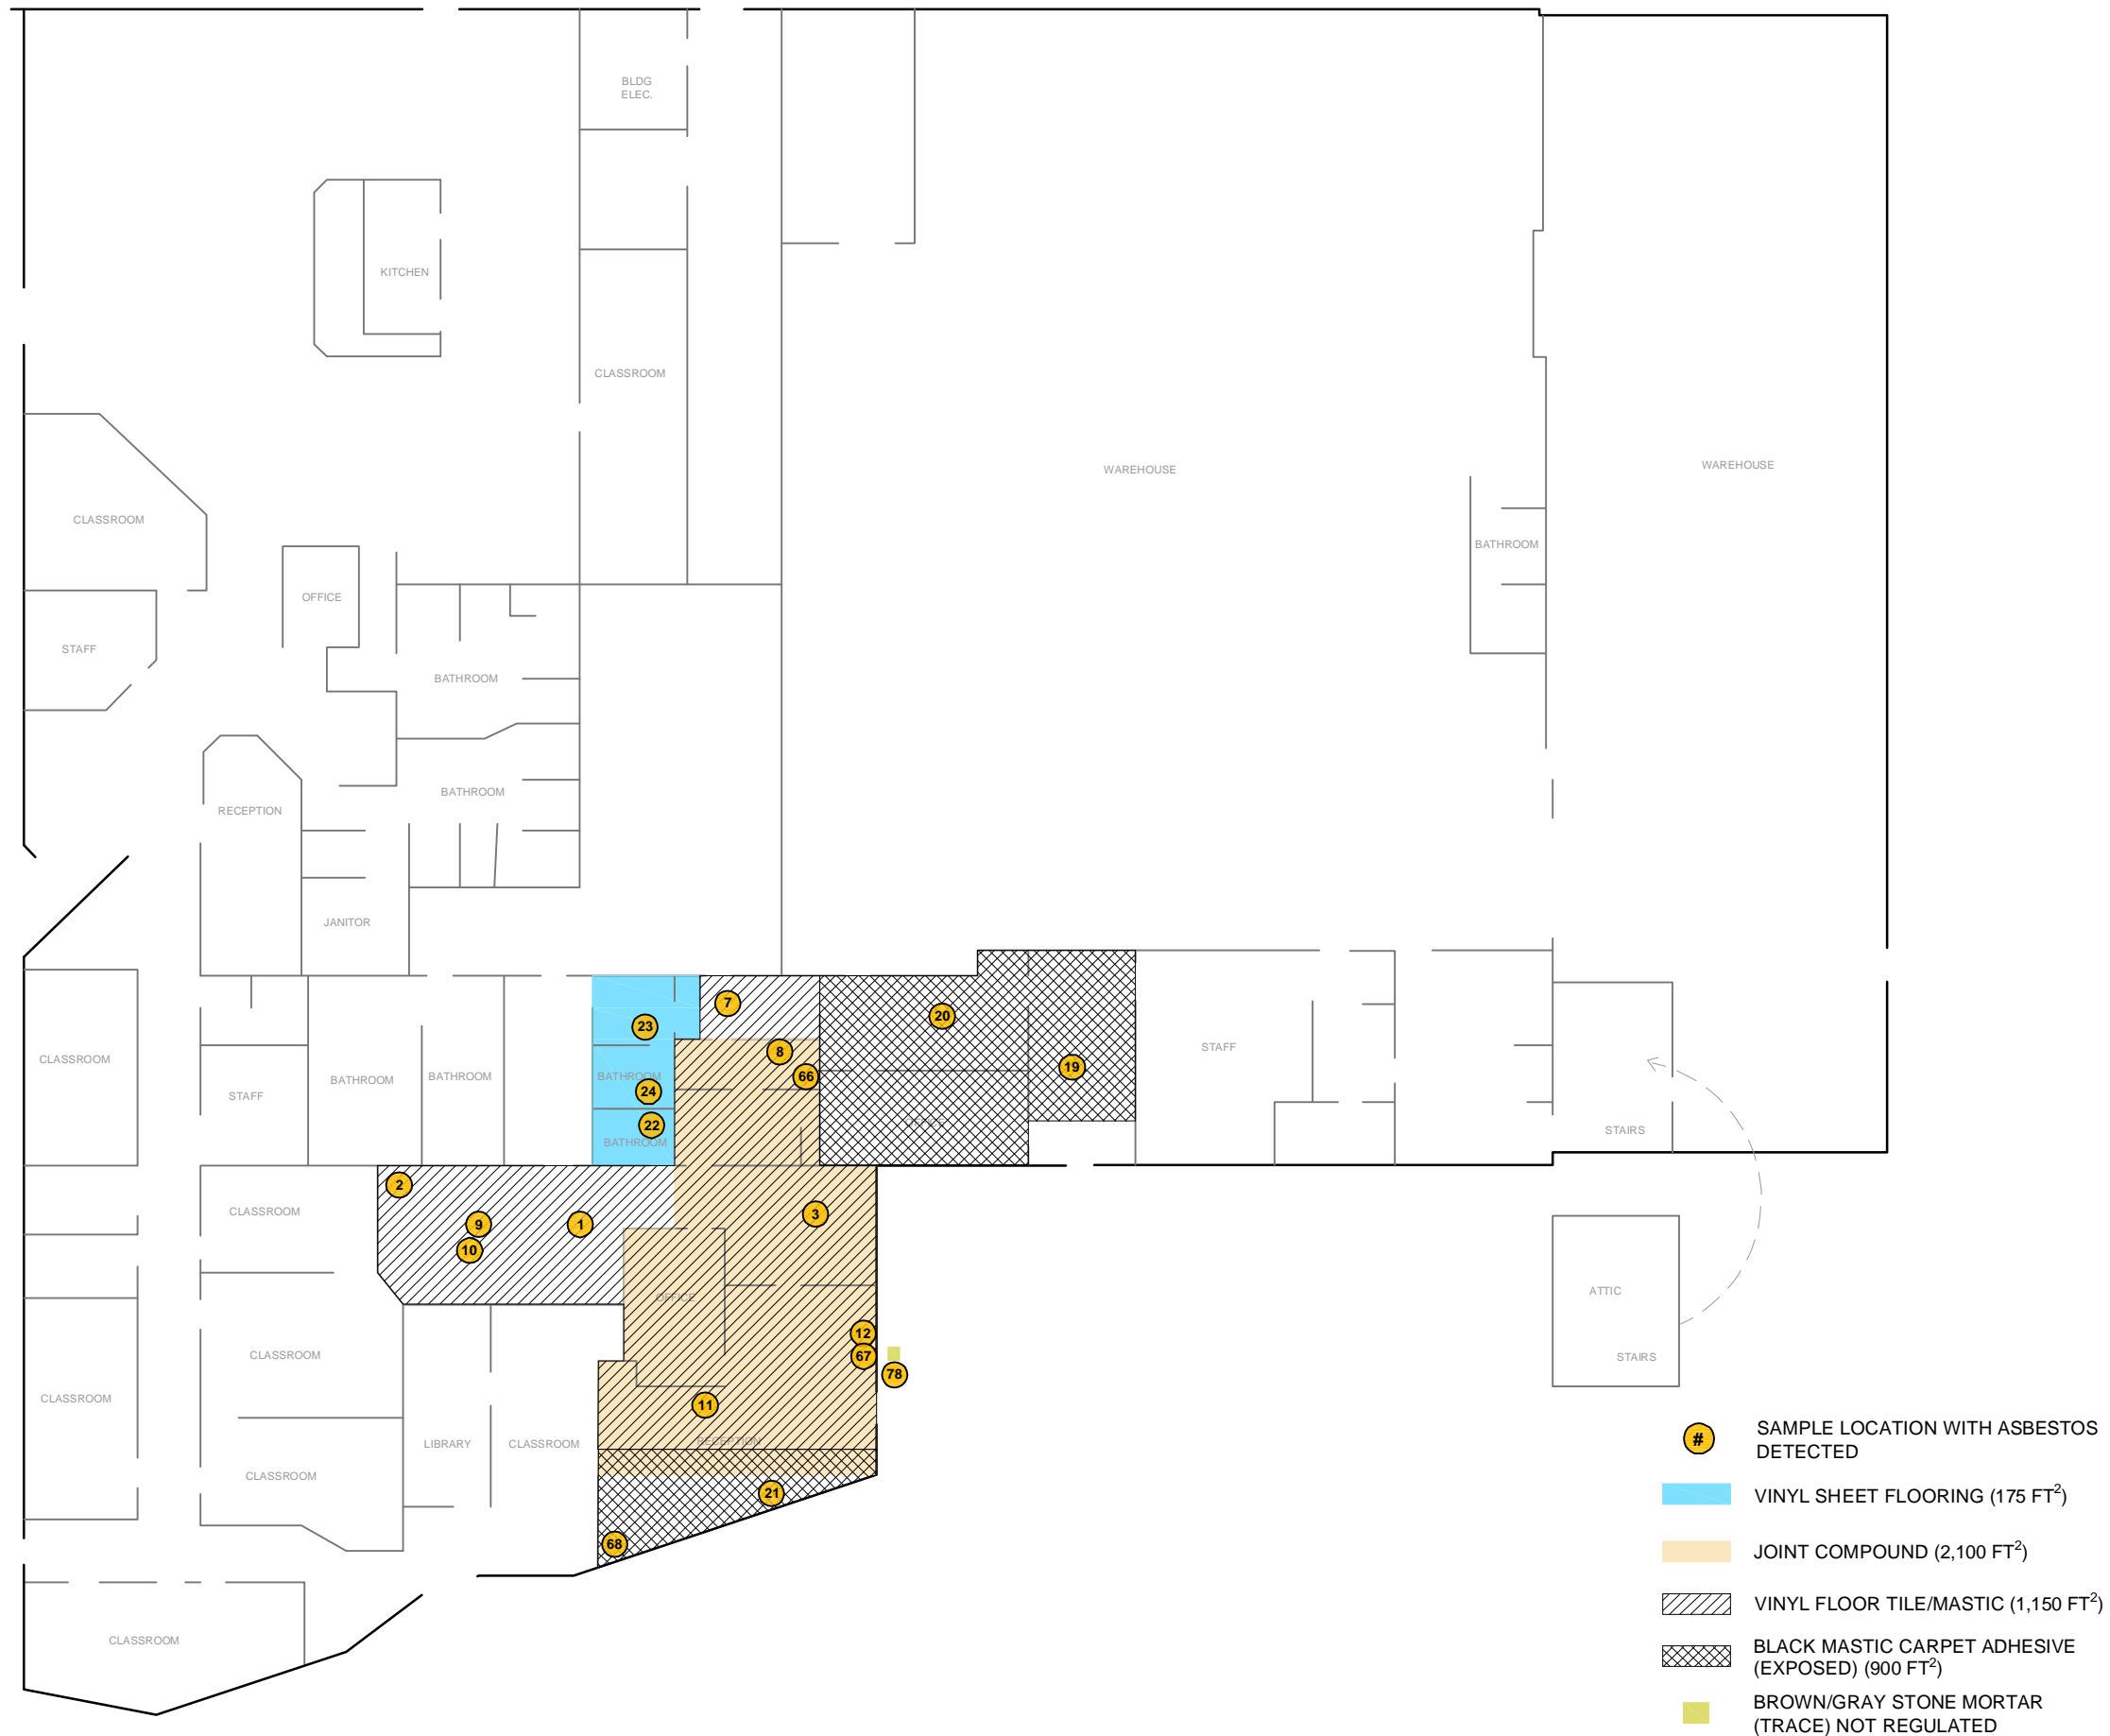
FIGURE 2
EXTENT OF ASBESTOS-CONTAINING MATERIALS

- Approximately 900 square feet of exposed black floor mastic with yellow carpet adhesive is located within the reception area (west side), the manager's offices, and the customer pick-up area. The black mastic contains 4 percent chrysotile asbestos and is represented by samples CCA-CABM-1, -2, and -3. The mastic is non-friable (Category II) and in fair condition. The ACM floor mastic should be removed by a licensed abatement contractor to reduce further material degradation, or temporarily covered with protective flooring materials to reduce material degradation until abatement can be achieved. The removed waste should be disposed of as non-friable (Category II) ACM.

- Approximately 175 square feet of white vinyl sheet flooring is located within the two center single restrooms and water heater room. The vinyl sheet flooring contains 8 percent chrysotile asbestos and is represented by samples CCA-VSF2-1, -2, and -3. The vinyl sheet flooring is in good condition and currently non-friable. The vinyl sheet flooring should be removed by a licensed abatement contractor if renovation work will disturb the materials. If removed intact, the removed waste can be disposed of as non-friable (Category I) ACM. If the material is not removed intact, then it must be disposed of as friable (regulated ACM).

- Approximately 2,100 square feet of joint compound in drywall wall system is located in the reception area and reception area offices. The joint compound contains 2 percent chrysotile asbestos and is represented by samples CCA-DWJC-1, -2, and -3. The joint compound is in good condition and non-friable. The drywall wall system should be removed by a licensed abatement contractor if renovation work will disturb the material. The removed waste can be disposed of as non-friable (Category II) ACM.

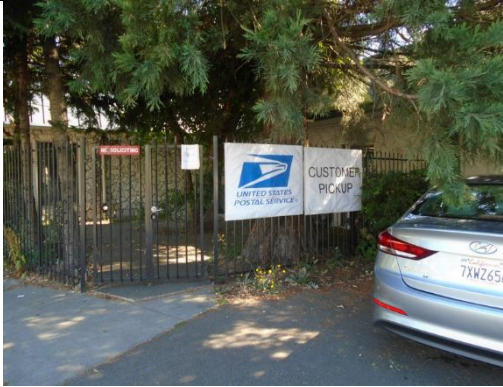
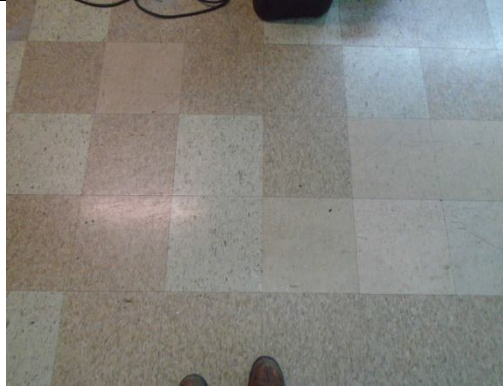
<p>Suite 101 - View of customer entrance for package pick up adjacent to Martin Luther King Boulevard.</p>	<p>Suite 101 - View of asbestos-containing material (ACM) and non-ACM 12-inch vinyl floor tile (VFT through VFT4) located in maintenance/facility office.</p>

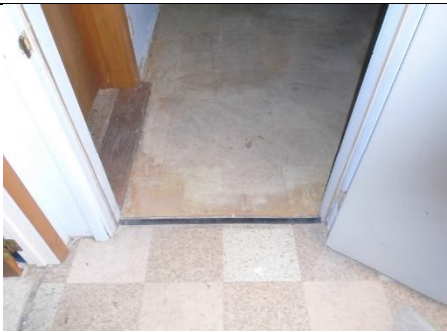
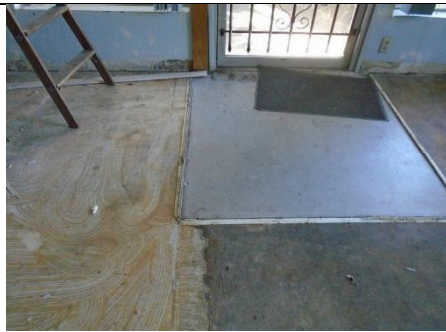
<p>Suite 101 - View of ACM/non-ACM vinyl floor tile (VFT through VFT4) with and without carpet adhesive.</p>	<p>Suite 101 - View of vinyl sheet flooring (white indent pattern) in reception entry, vinyl floor tile with carpet adhesive, and ACM black mastic with carpet adhesive on concrete.</p>

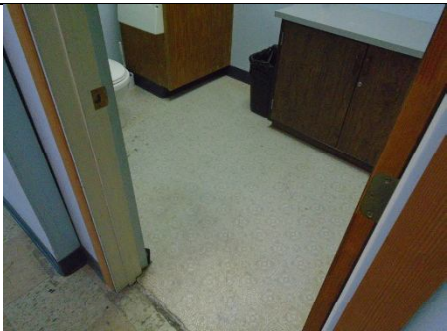
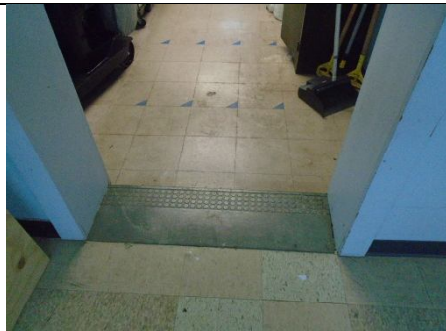
<p>Suite 101 - View of ACM vinyl sheet flooring (VSF2 white/tan pattern) in central restrooms and water heater room.</p>	<p>Suite 101 - View of VFT2 with blue tile accents (VFT5) in maintenance office.</p>

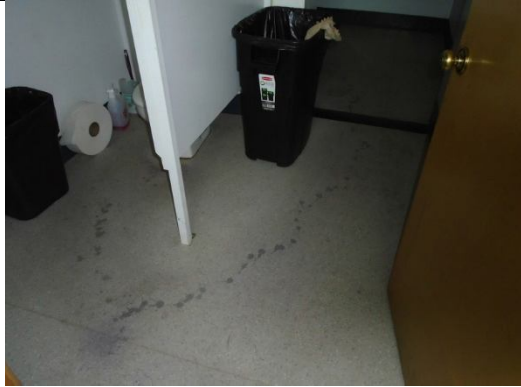
Suite 101 - View of vinyl sheet flooring (VSF3) in men's restroom.	Suite 101 - View of vinyl sheet flooring (VSF4) in warehouse restroom.

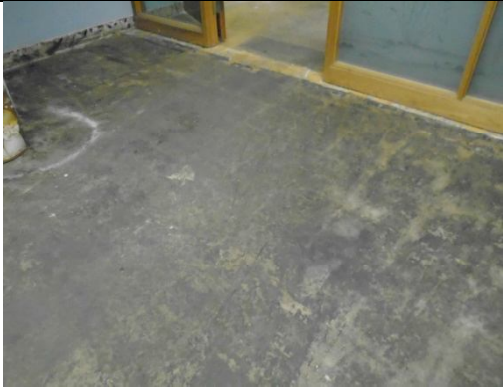
Suite 101 - View of ACM black mastic with carpet adhesive and brown cove base adhesive.	Suite 101 - A view of ceiling tiles.

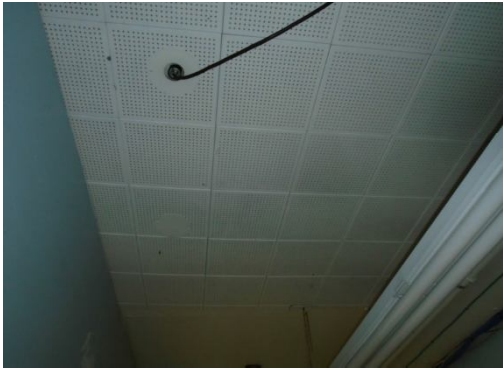
Suite 101 - View of glue on ceiling tiles.	Suite 101 - View of glue on ceiling tiles above lay-in ceiling tiles.

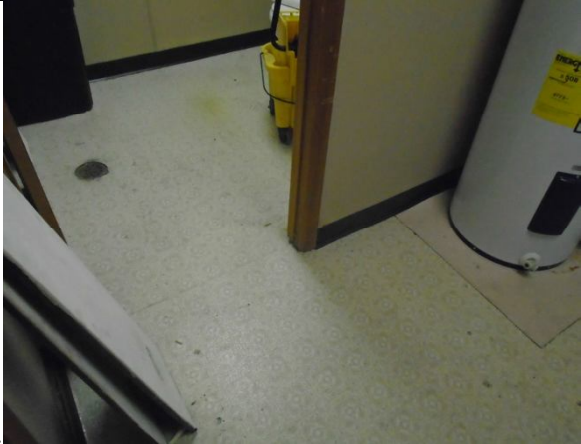
<p>Suite 101 - View of ACM vinyl sheet flooring (VSF2) in water heater room and restroom.</p>	<p>Suite 101 - View of wall mastic.</p>

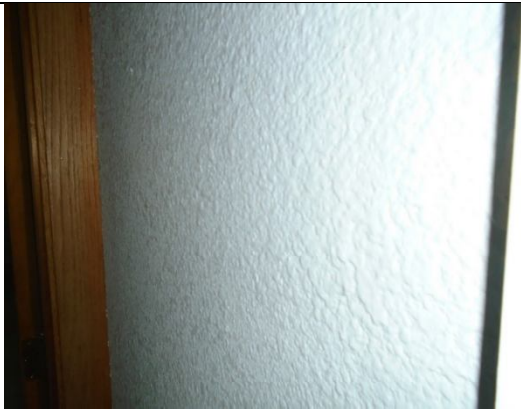
<p>Suite 101 - A view of knockdown drywall texture over drywall wall system with ACM joint compound.</p>	<p>Suite 101 - View of moisture damage on smooth drywall (DWJC2).</p>

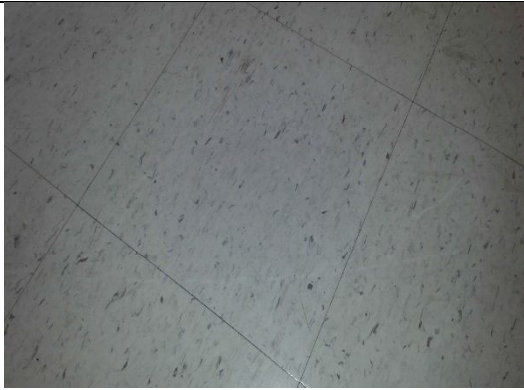
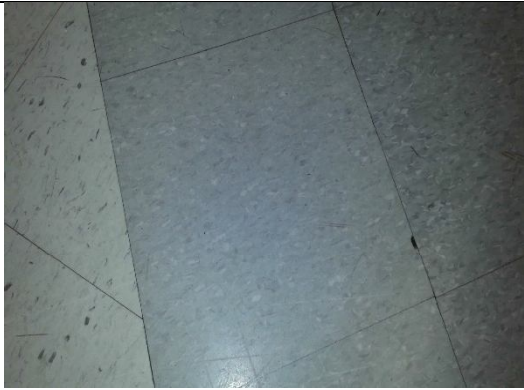
Suite 100 - 12-inch vinyl floor tile, white with grey specks and black mastic.	Suite 100 - 12-inch vinyl floor tile, light grey with white specks and black mastic.

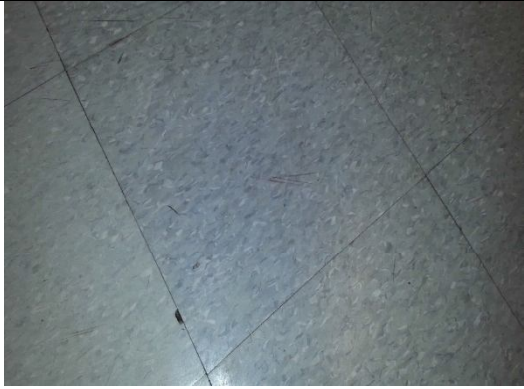
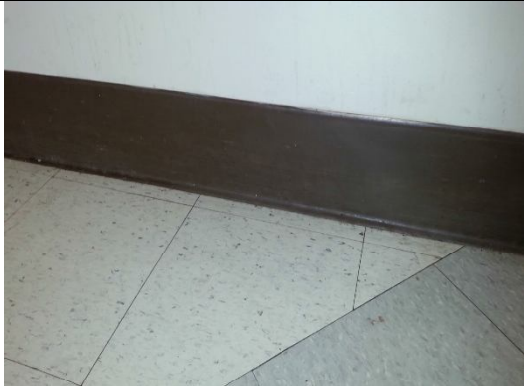
Suite 100 - 12-inch vinyl floor tile, grey with white specks, tan, and black mastic.	Suite 100 - 7-inch vinyl cove base, brown with beige adhesive.

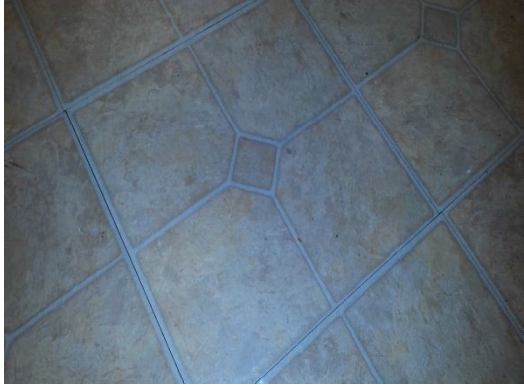
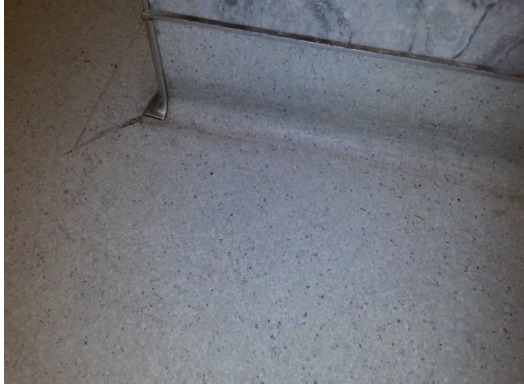
Suite 100 - 12-inch vinyl floor tile, tan square pattern, clear, and black mastic.	Suite 100 - Vinyl sheet flooring, grey speckled, with grey backing, tan, and black mastic.

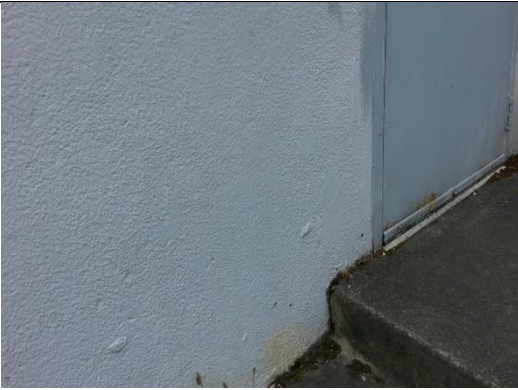
Suite 100 exterior - wall texture.
