LIMITED GOOD FAITH **ASBESTOS SURVEY**

Property address: 5915 Orchard Street W, Tacoma WA 98467

Job number: 21-0614

THIS SURVEY IS LIMITED TO THE INTERIOR DEMOLITION PROJECT PLANNED FOR THE BASEMENT ONLY.

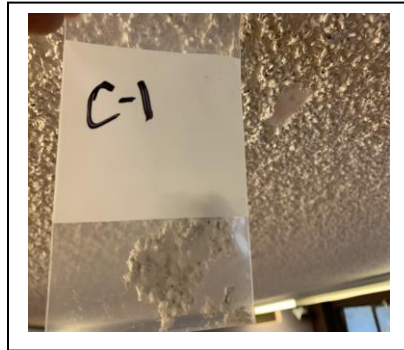
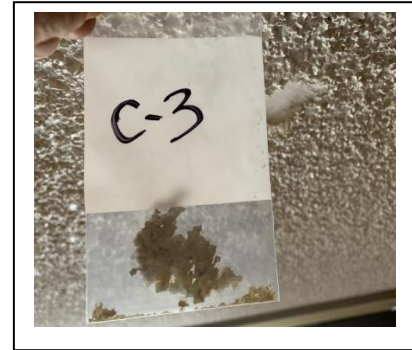
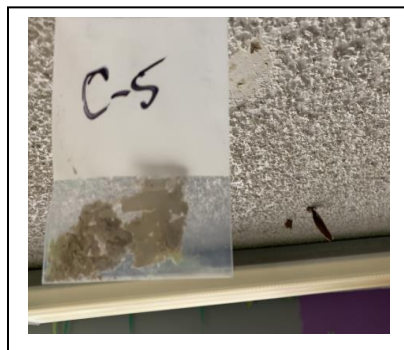
- **The popcorn ceiling texture throughout.**
(Samples #C-1, #C-2, #C-3, #C-4, #C-5).

Pictures #C-2, #C-4
Missing

Abatement and disposal of asbestos-containing materials must be conducted by a Washington State Licensed Asbestos Abatement Contractor using Washington State Certified Asbestos Abatement Workers. Should employees or contract personnel encounter any suspect asbestos-containing materials, it is their responsibility to:

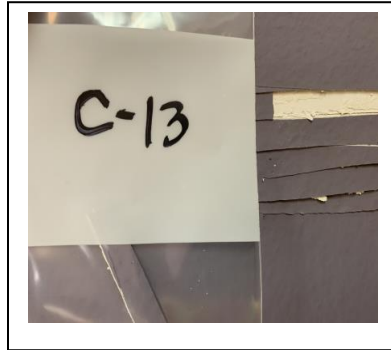
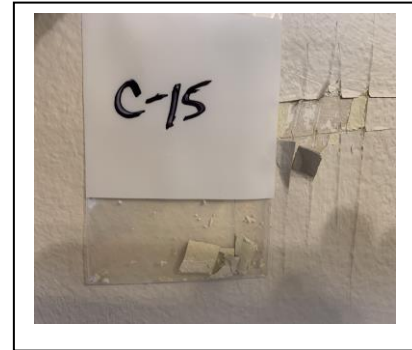
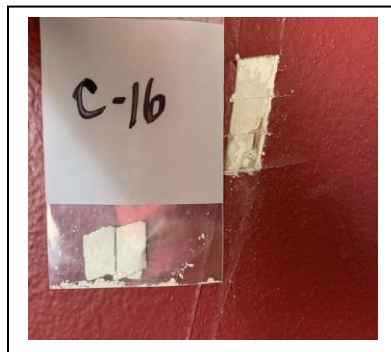
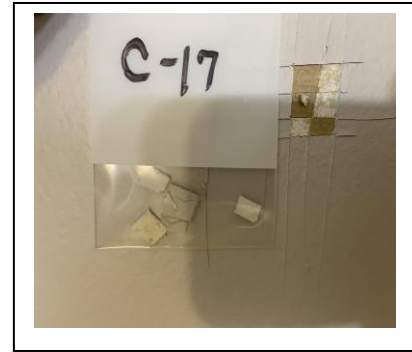
- The orange peel wall texture throughout.
(Samples #C-13, #C-15, #C-16, #C-17).

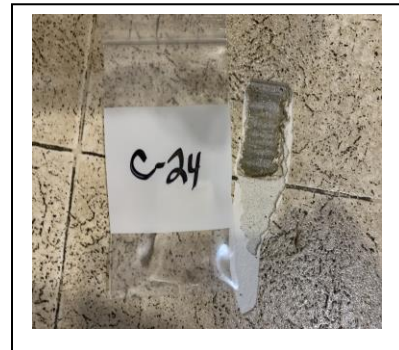
- The bottom layer of beige/grey Vinyl, located in the women's bathroom on a concrete substrate.
(Sample #C-24 Layer C).
