# **Limited Pre-Renovation Hazardous Materials Survey Report**

Zosel Dam Gate Improvements  
1 14<sup>th</sup> Avenue  
Oroville, Washington

March 8, 2024  
PBS Project 64598.016

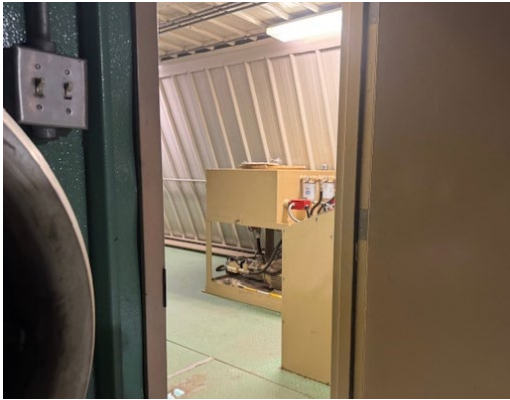
| MATERIAL DESCRIPTION / SUBSTRATE | HOMOGENOUS MATERIAL ID | COLOR/ PATTERN / TEXTURE | ROOM / LOCATION SAMPLED | ASBESTOS PERCENT % / ASBESTIFORM | CAT | FRIABLE | CONDITION | QUANTITY |
|---|---|---|---|---|---|---|---|---|
| Fire Door Frame Caulk | HM3 | Gray | Upper Level Generator Room | 3% Chrysotile | M | NF | Fair | ~40 LF |

Photo 1. Fire door frame caulk (south door), gray - contained asbestos.

PBS recommends that all ACMs to be impacted by the renovation be removed prior to renovation activities. A qualified Washington State licensed asbestos abatement contractor should be employed to remove all such ACMs according to applicable local, state, and federal regulations.

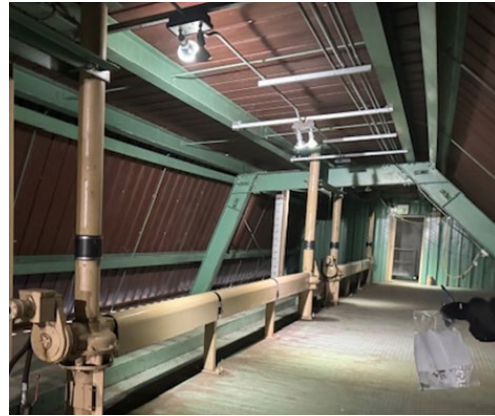
Photo 2. Fire door frame caulk (north door), gray - contained asbestos.

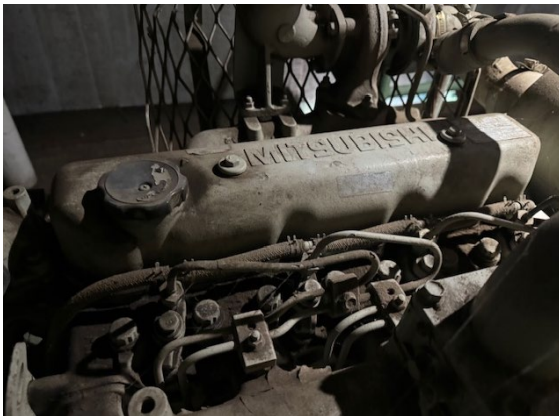
Photo 3. Merlin generator in generator room – presumed to contain asbestos components.

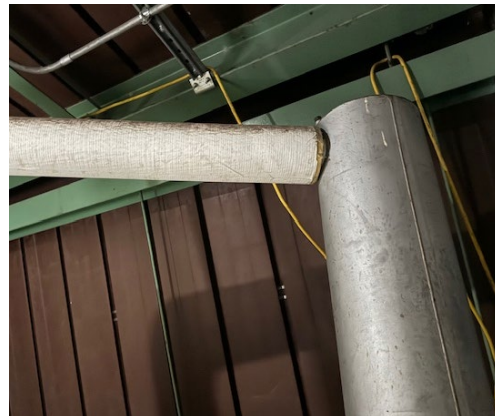
| MATERIAL DESCRIPTION / SUBSTRATE | HOMOGENOUS MATERIAL ID | COLOR/ PATTERN / TEXTURE | ROOM / LOCATION SAMPLED | ASBESTOS PERCENT % / ASBESTIFORM | CAT | FRIABLE | CONDITION | QUANTITY |
|---|---|---|---|---|---|---|---|---|
| Silver heat tempered TSI | HM2 | Silver | Upper Level Generator Room | 8% Chrysotile | TSI | F | Fair | ~6 LF |

Photo 4. Silver heat-tempered thermal system pipe insulation in generator room contained asbestos.

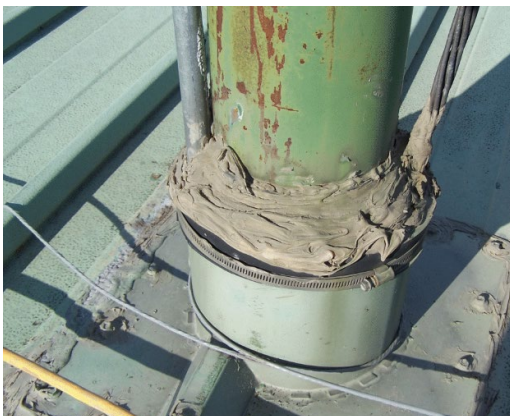
| MATERIAL DESCRIPTION / SUBSTRATE | HOMOGENOUS MATERIAL ID | COLOR/ PATTERN / TEXTURE | ROOM / LOCATION SAMPLED | ASBESTOS PERCENT % / ASBESTIFORM | CAT | FRIABLE | CONDITION | QUANTITY |
|---|---|---|---|---|---|---|---|---|
| Roof Penetration Caulk | HM1 | Gray / Silver | Roof | 3% Chrysotile | M | NF | Fair | ~40 LF |

Photo 5. Exterior roof penetration caulk, gray/silver, contained asbestos. It should be presumed all penetration locations contain asbestos.

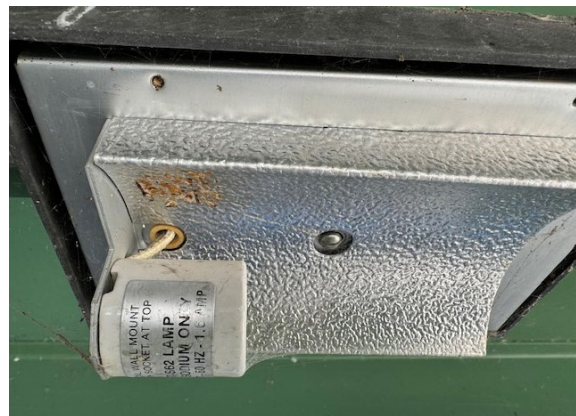
PBS observed approximately twenty-five (25) square shaped socket light fixtures with heatshield backing and wiring insulation that should be presumed to contain asbestos.

Photo 5. Square socket lamp fixtures are presumed to contain asbestos heat shielding and insulated wire – all square socket lamp fixtures throughout.

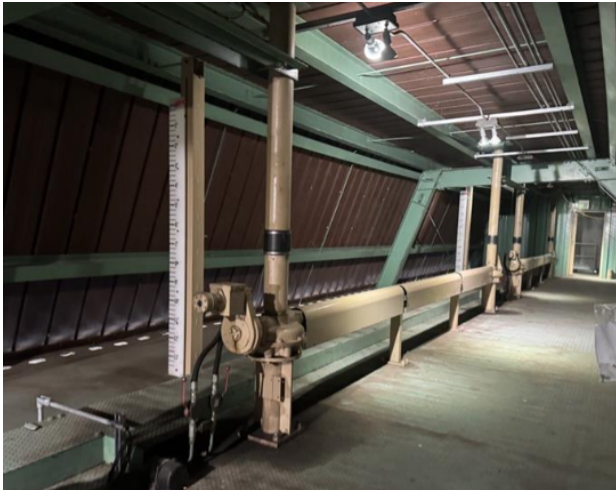
Photo 7. PCBs were identified in the hydraulic grease used on the gate lifting shaft in the main upper level of the control structure.

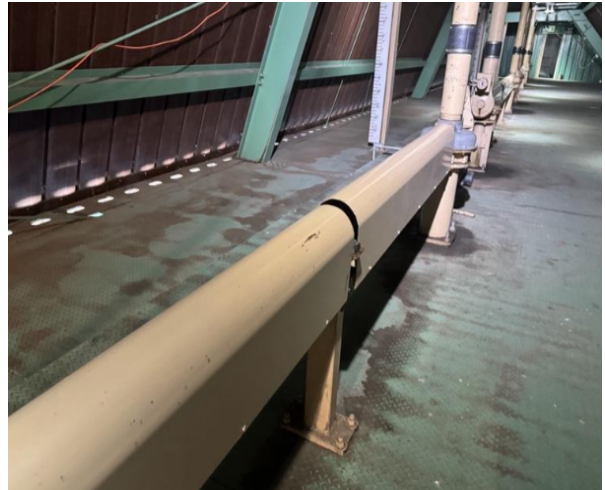
PCBs were detected in levels over 50 ppm in the hydraulic grease used on the gate lifting shaft in the upper level main room. The hydraulic grease staining was also present throughout the upper level main area decking directly beneath the gate lifting shaft and should be taken into consideration during and remedial activities.

Photo 8. PCBs were identified in the hydraulic grease used on the gate lifting shaft in the main upper level of the control structure and was observed throughout upper level decking and decking areas where staining is present, should be considered contaminated.

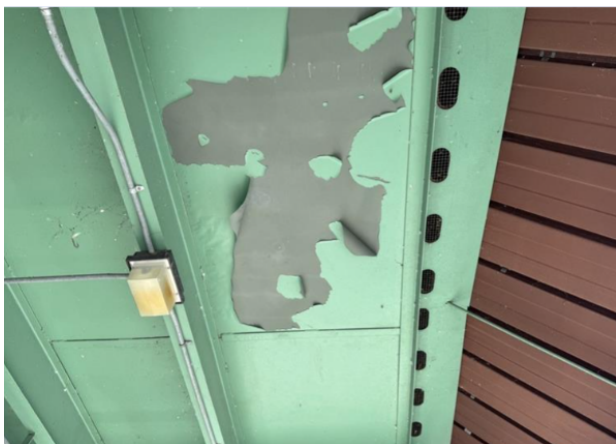
Photo 9. Square shaped socket lamps with square covers contain heat shield backing and insulated wiring that should be presumed to contain asbestos. Lead paint was identified throughout the structure and was peeling, chipping, flaking primarily on ceilings of dam platform main level of the structure.

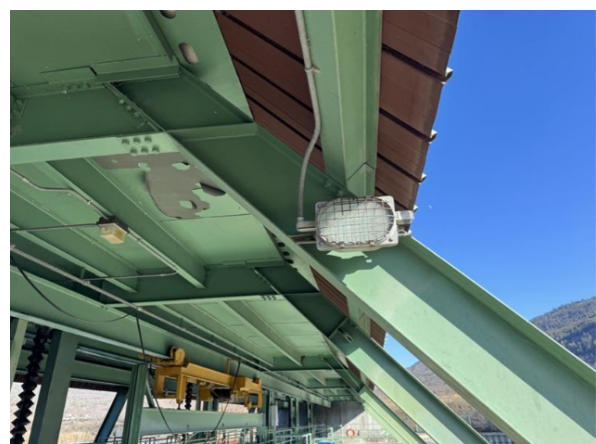
Photo 10. Square shaped socket lamps with square covers contain heat shield backing and insulated wiring that should be presumed to contain asbestos. oval caged light fixtures should be presumed to house mercury-containing HID/bulbs.

Any electronic equipment with liquid mercury bulbs or Merciod switches should have the mercury components carefully removed by properly trained personnel using appropriate work practices. The mercury components should then be containerized prior to transporting to a recycling facility permitted to accept such waste. Any broken tubes or switches should be promptly cleaned by properly trained personnel using appropriate work practices and worker protection.
